INDOOR AIR QUALITY ASSESSMENT

**Revere Public Library
179 Beach Street
Revere, Massachusetts**

Prepared by:
Massachusetts Department of Public Health
Bureau of Environmental Health Assessment
July, 2001

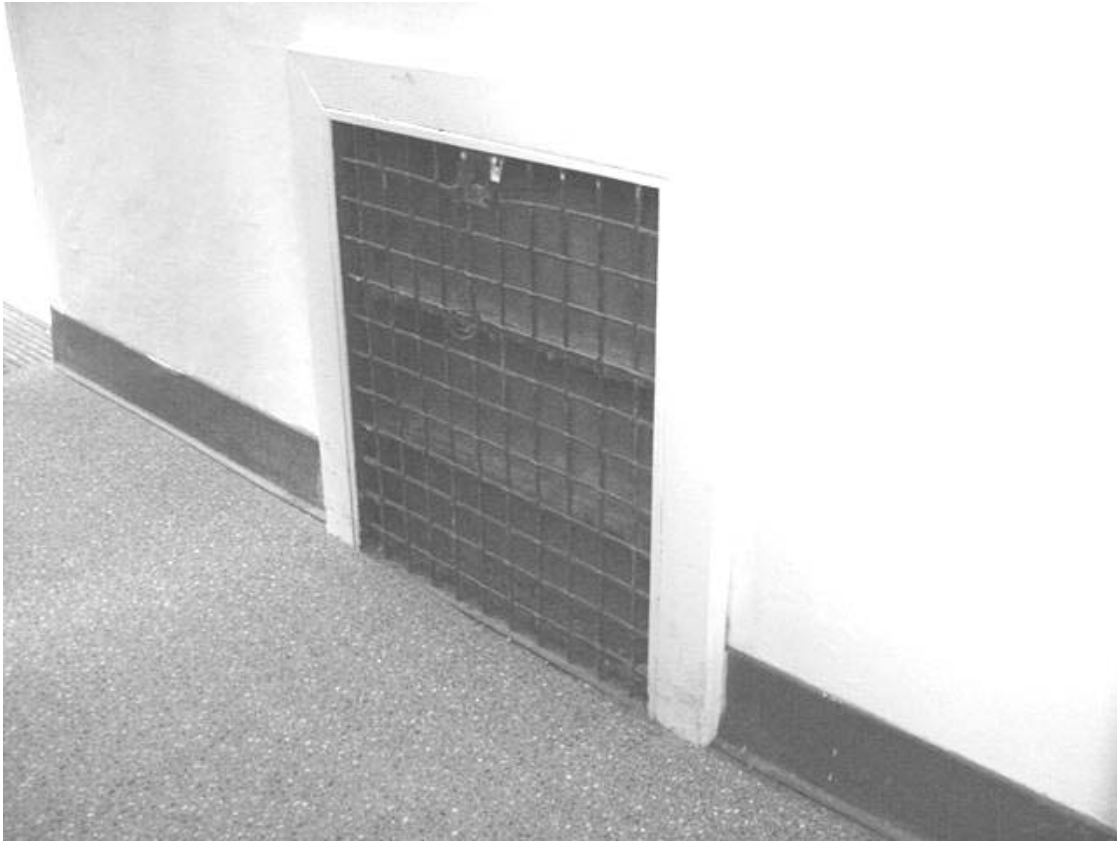
Picture 2

Ventilation was originally provided by a natural/gravity ventilation system that has been abandoned. Fresh air to the main library was provided by a series of louvered vents. Each wing of the library has an approximately 3' x 3' grated air vent at floor level (see Picture 2), which is connected by ductwork to a "hearth"-like opening in the basement. One of these vents was sealed; the other was not.

Natural/Gravity Feed Vent

2. Continue plans for renovation of the building structure and the installation of a modern mechanical HVAC system.
3. Seal original gravity feed exhaust vents at both ends to prevent drafts. Ensure all systems within airshafts are deactivated. Regulate airflow with the use of openable windows to control for comfort. Care should be taken to ensure windows are properly closed at the close of business to avoid water damage, the freezing of pipes and potential flooding.

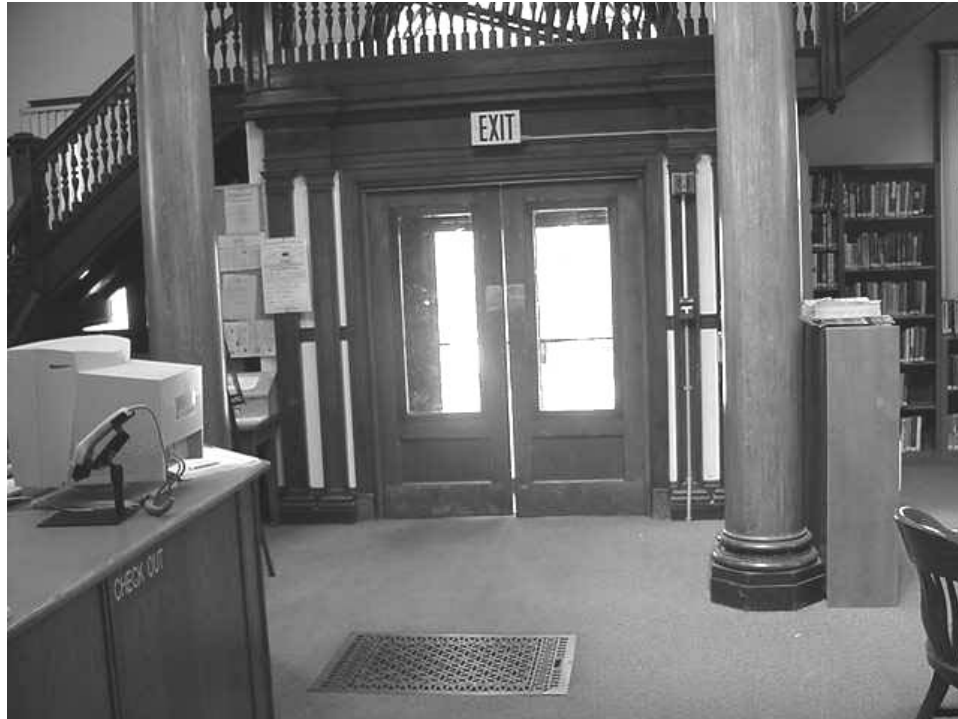
Picture 3

Circulation Desk and Front Entrance Note, Spaces around Doors

5. To avoid drafts, seal main entrance with weather stripping and a door sweep. Reactivate radiator in vestibule to temper incoming air.
6. Repair and/or replace thermostats as necessary to maintain control of comfort.

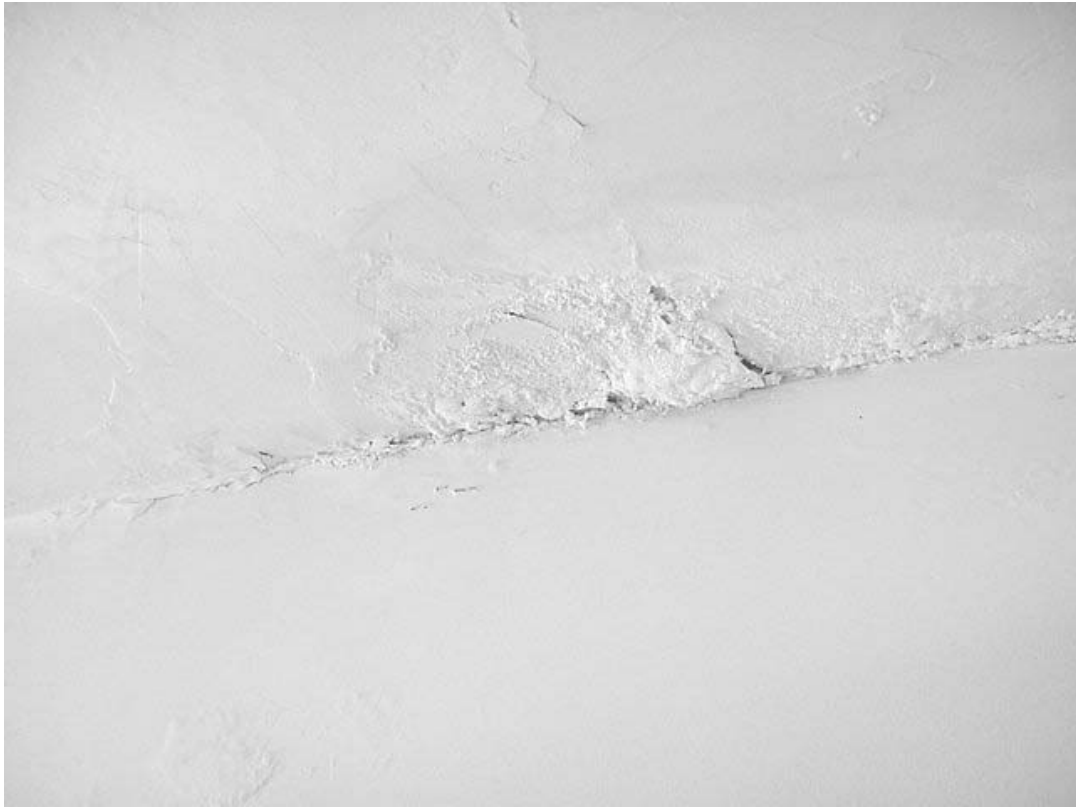
Picture 4

Several areas on the second floor had water-damaged walls and/or ceilings, which is evidence of roof or plumbing leaks. Water intrusion was evident by the presence of efflorescence (e.g., mineral deposits) and water-damaged wall and ceiling plaster (see Pictures 4 & 5). Efflorescence is a characteristic sign of water damage to brick and mortar, but it is not mold growth. As moisture penetrates and works its way through mortar around brick, water-soluble compounds in bricks and mortar dissolve, creating a solution. As the solution moves to the surface of the brick or mortar, water evaporates, leaving behind white, powdery mineral deposits. Water-damaged building materials can provide a source of microbial growth, especially if they are moistened repeatedly. These materials should be replaced after a water leak is discovered.

Water Damaged Ceiling Plaster (Efflorescence)

7. Continue to work with roofing contractor to identify and repair any existing water leaks and replace any remaining water-stained building materials. Examine above and around these areas for microbial growth. Disinfect areas of water leaks with an appropriate antimicrobial as needed.

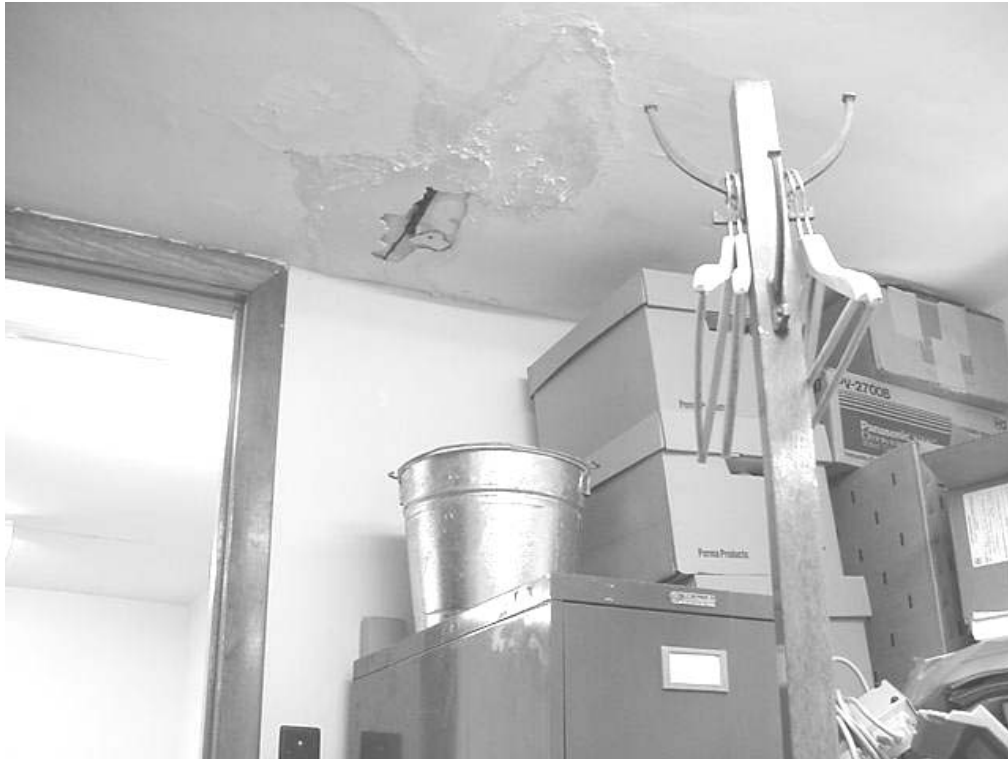
Picture 5

An active leak was reported in the mezzanine storage room and a bucket was stationed below to collect rainwater (see Picture 5). Possible mold growth on water damaged ceiling plaster was observed in this area (see Picture 6). Mr. Rice reported that a roofing contractor has visited the site a number of times and is in the process of tracing the source of the leak.

Water Damaged Ceiling Plaster and Bucket to Collect Rainwater in Mezzanine Storage Room

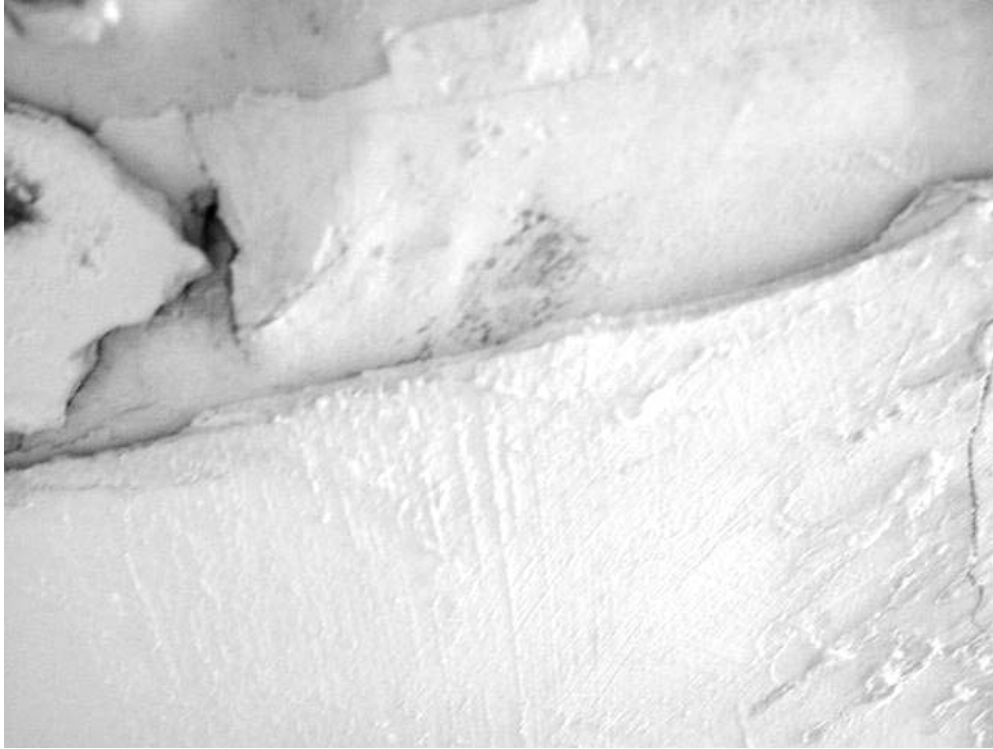
Picture 6

**Close-up of Water Damaged Ceiling Plaster and Potential Microbial Growth
as Indicated by Dark Stains**

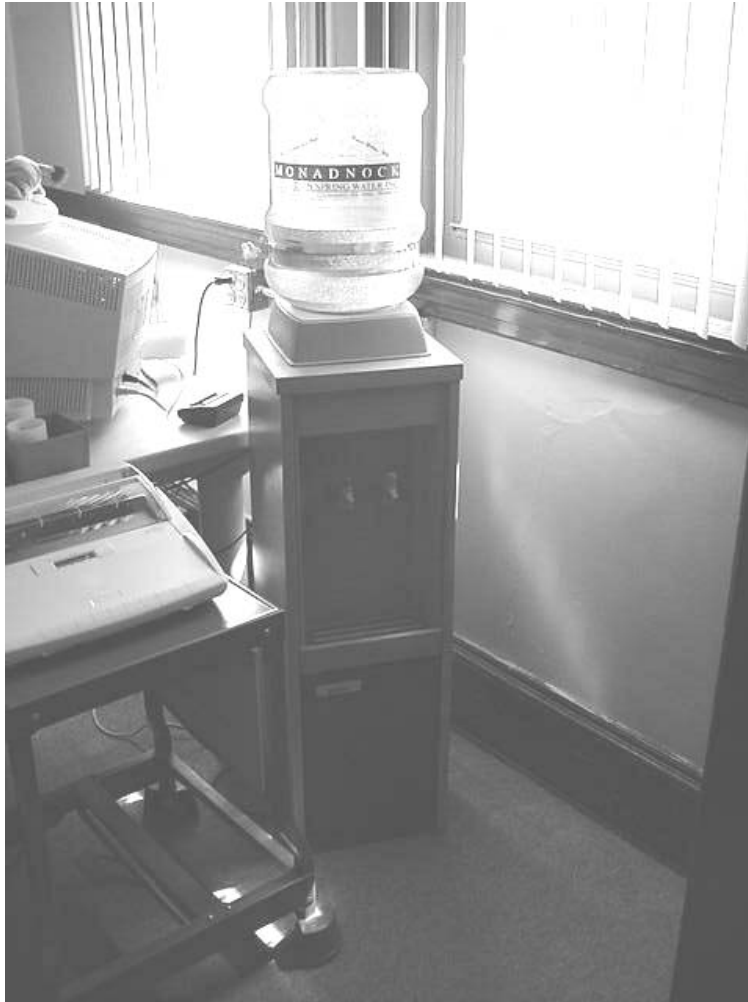
Picture 7

A water cooler was observed on the carpet in the business office and in the north basement classroom (see Picture 7). The American Conference of Governmental Industrial Hygienists (ACGIH) recommends that carpeting be dried with fans and heating within 24 hours of becoming wet (ACGIH, 1989). If carpets are not dried within this time frame, mold growth may occur. Once mold has colonized porous materials, they are difficult to clean and should be removed. To avoid water damage to carpeting and/or potential mold growth, a water-resistant material such as plastic or rubber matting should be installed beneath this water cooler.

Water Cooler on Carpeting

8. Relocate or place tile or rubber matting underneath water coolers in carpeted areas.
9. Clean and maintain dehumidifiers as per the manufacturer's instructions.

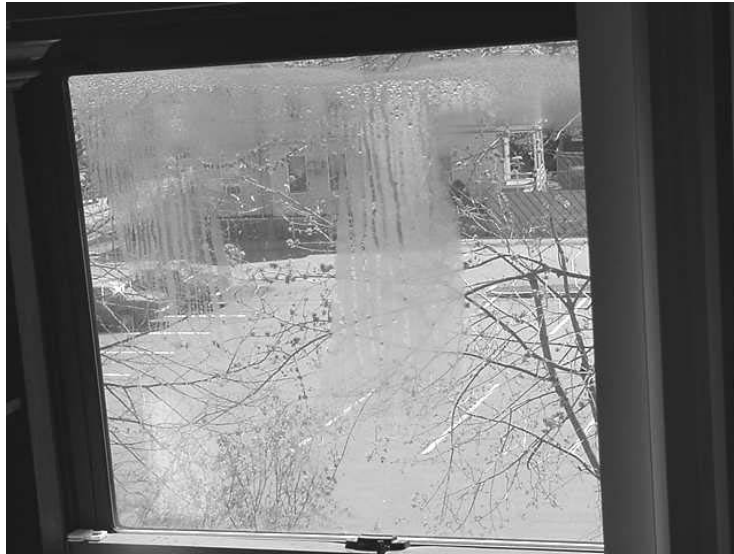
Picture 8

Water vapor was observed collecting inside the double-paned window glass in a number of areas (see Picture 8). This indicates that the window's water seal is no longer

intact. Water penetration through windows/frames can lead to mold growth under certain conditions. Replacement of caulking and repairs of window leaks are necessary to prevent further water penetration. Existing windows are scheduled to be replaced during the renovation project.

Condensation between Window Frames Indicating Faulty Seal

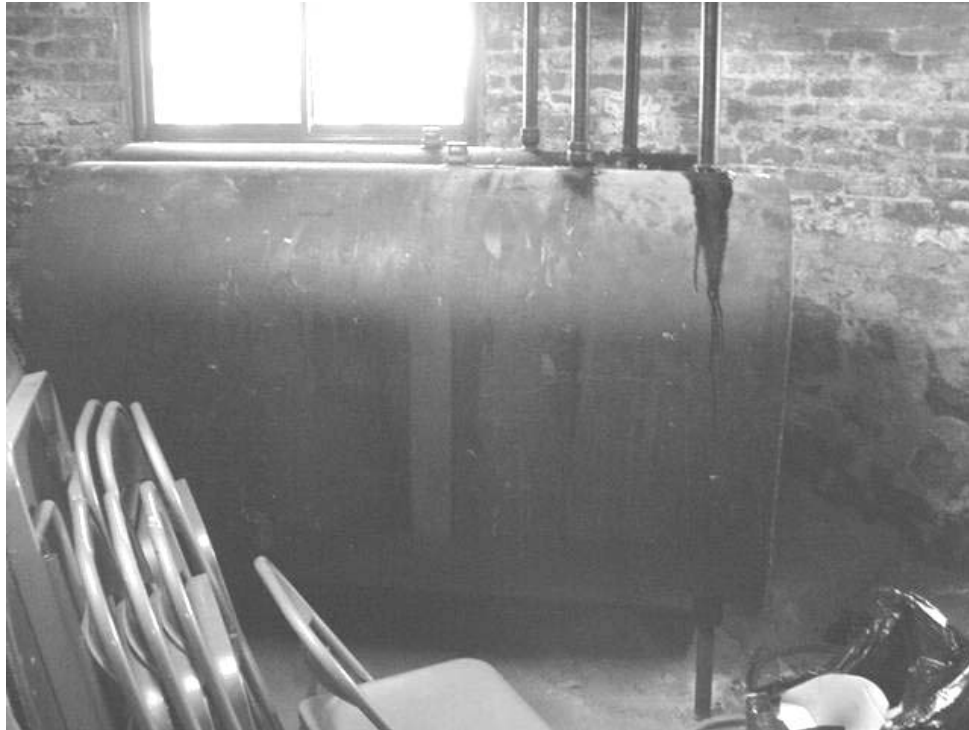
Picture 9

Several other conditions that can potentially affect indoor air quality were also identified. As discussed previously, the children's library is located directly adjacent to the boiler room. The boiler room contains a large oil-fired furnace and two 500-gallon oil tanks (see Pictures 9 & 10), and is separated from the children's library by a wood-framed, sheetrock wall equipped with a door (see Picture 11).

Due to differences in temperature and pressurization between rooms, air currents are created that can migrate from the boiler room into the adjacent children's library carrying odors, waste heat and particulates. In addition, petroleum products contain volatile organic compounds (VOCs), which can be irritating to the eyes, nose and throat. A number of different pathways were identified including spaces around doors, walls, utility holes and

(2) 500-Gallon Oil Tanks Located in Basement/Boiler Room

1. In order to prevent boiler room/fuel odors from penetrating into the children's library walls separating the children's library from the boiler room, the area needs to be made as "air-tight" as possible. This will include:
 - sealing all utility holes with an air-tight, foam-like material (see Picture 13);
 - ensuring that all wallboard joints and seams along boiler room/library are sealed so no spaces exist between the walls and the ceiling;
 - sealing spaces around doors with weather stripping and installing a door sweep.

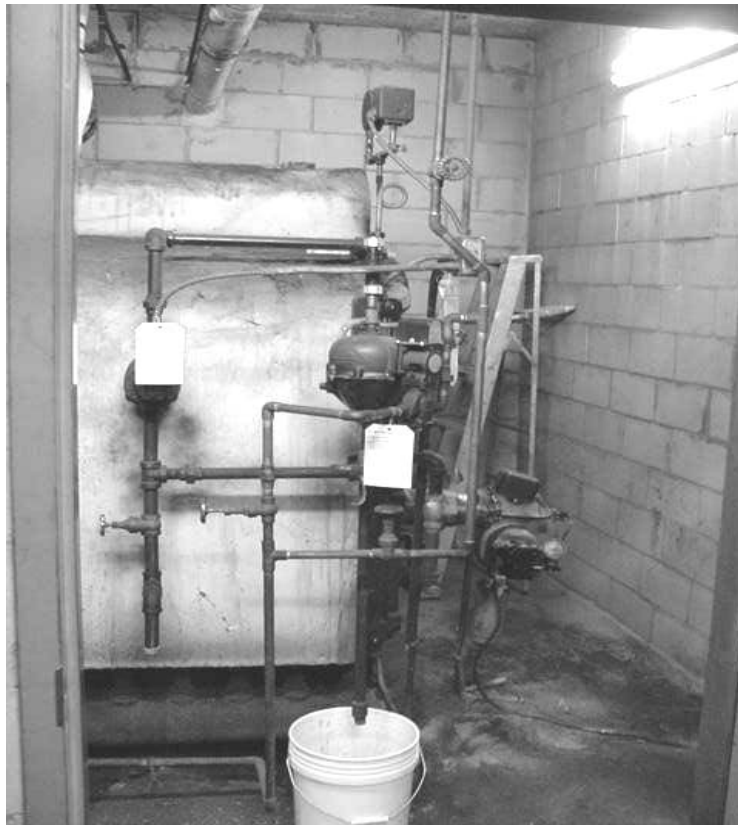
Picture 10

During operation, the oil burner/furnace generates heat and odors associated with the combustion of fossil fuel. This was evidenced by odor complaints from a library occupant, several minutes after the boiler had "fired-up" while BEHA staff and Mr. Rice were examining conditions in the boiler room.

Boiler Plant Adjacent to Children's Library

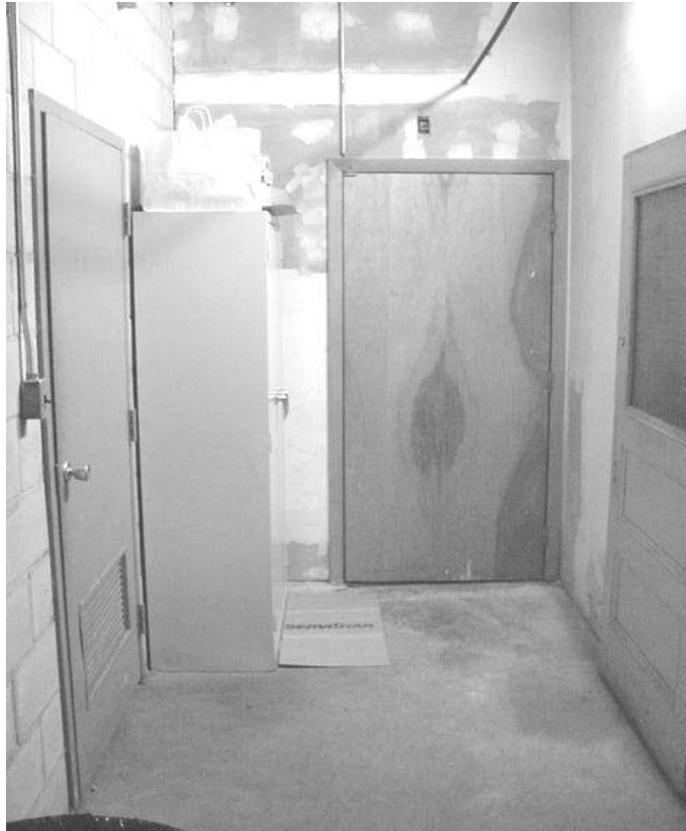
Picture 11

above ceiling tiles in the ceiling plenum (see Pictures 11 & 12). These pathways can serve as egress for vapors, fumes, dusts and odors between areas.

**Sheetrock Wall Separating Boiler Room from Children's Library
Note Spaces around Door**

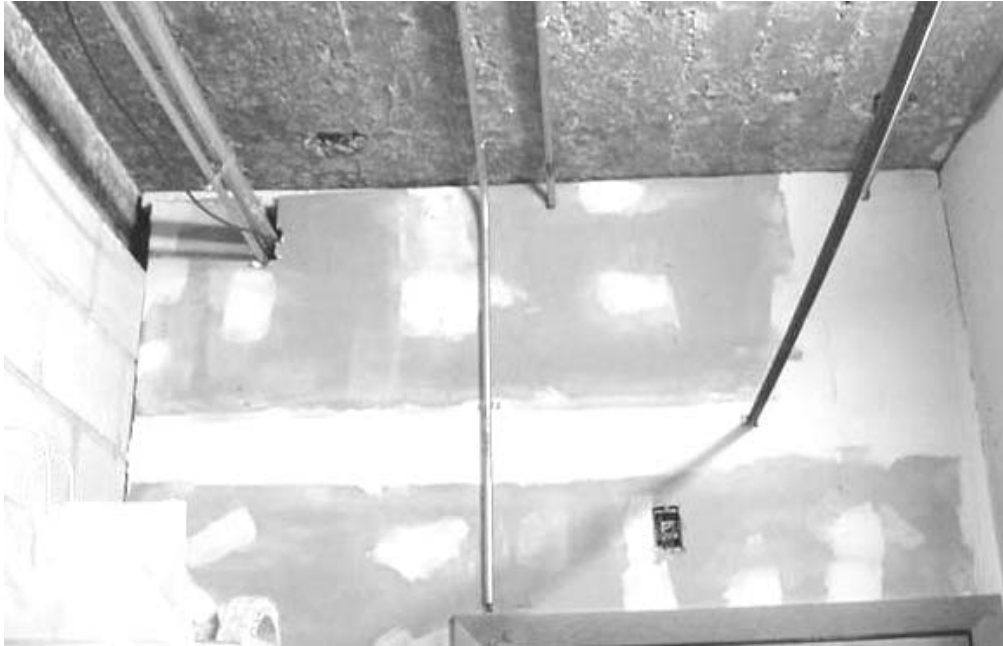
Picture 12

Utility Holes in Sheetrock Wall Boiler Room/Children's Library

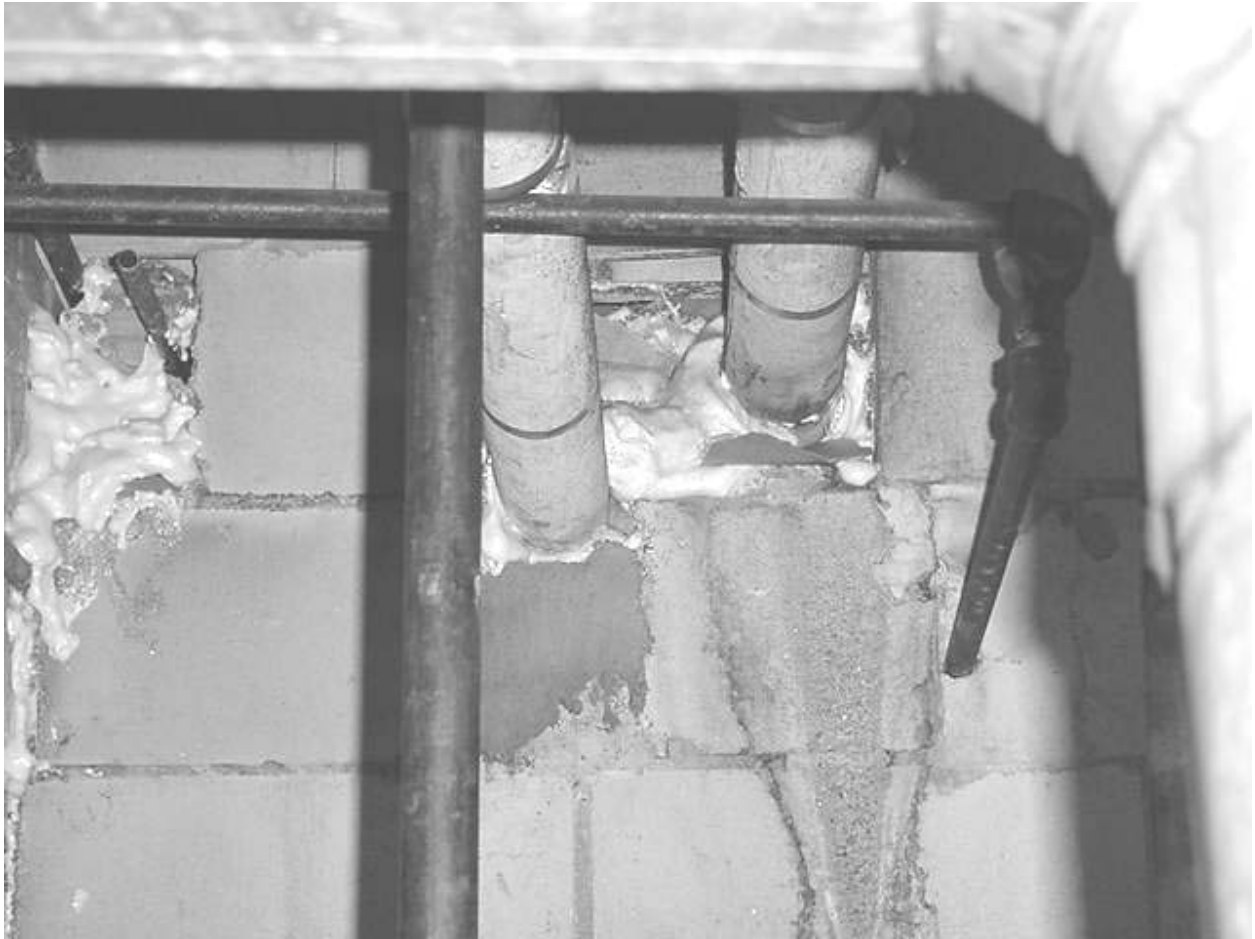
Picture 13

Foam Insulation Material around Pipes in Boiler Room
